IMCA Safety Flashes summarise key safety matters and incidents, allowing lessons to be more easily learnt for the benefit of all. The effectiveness of the IMCA Safety Flash system depends on members sharing information and so avoiding repeat incidents. Please consider adding [safetyreports@imca-int.com](mailto:safetyreports@imca-int.com) to your internal distribution list for safety alerts or manually submitting information on incidents you consider may be relevant. All information is anonymised or sanitised, as appropriate.

## 1 Man overboard during motion compensated gangway transfer

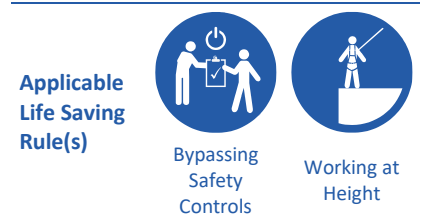
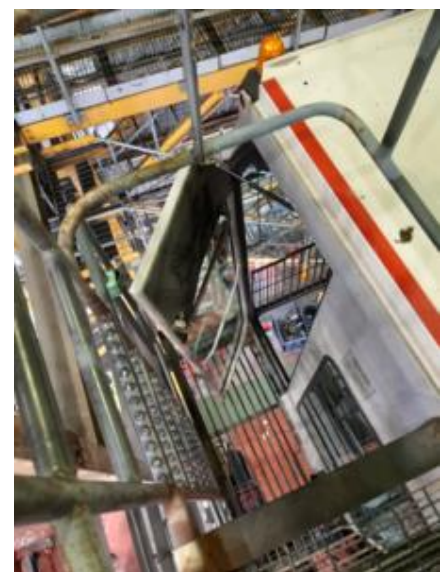
During a client inspection, the sight glass on a vessel main engine lubricating oil storage tank was found to have been fitted with an unauthorised and homemade 'clamp'. An unauthorised 'clamp' was installed on the storage tank without any consideration for the potential consequences. This clamp kept the self-closing valve open at all times, contravening mandatory regulations, company standards and exposing the crew, the vessel and the environment to a significant fire, safety and environmental risk.

- The modification was made to save time during a routine task, without due consideration to the potential consequences and hazards;
- No onboard routine inspections, safety walk-rounds, observations or interventions had raised a concern regarding the modification.
