## 1 Main Crane failure during load test

## 2 AC vent unit cover dislodged and fell 1.7m

### 3 Dropped sheave and clump weight

#### 4 UK HSE: Incident during rig decommissioning leads to fatality

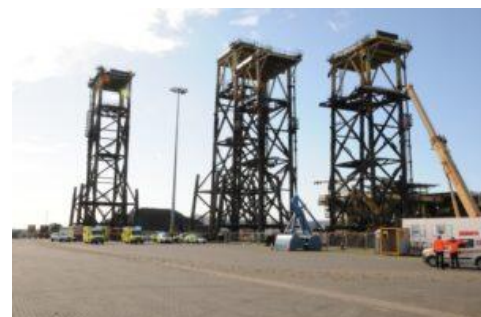
- Serious failings with the planning and the risk assessment which did not adequately cover the planned works;
- Shortcomings in supervision;
- The company did not risk assess the skirt pile being removed as it was considered low risk. As a result there was no cutting plan or safe system of work for the skirt pile.

*Emergency services attended the scene following the incident*

HSE noted that demolition, dismantling and structural alteration work must be carefully planned and carried out – HSE has guidance on this.

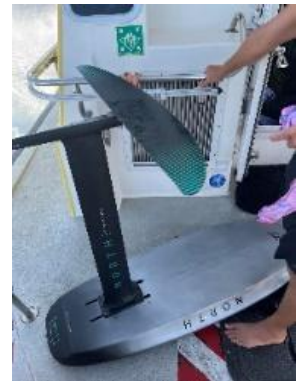
The crew of a small pilot boat at sea spotted a surfer in distress. The skipper of the boat approached the area and using the vessel's megaphone communicated with the surfer who acknowledged that he was in distress. The MOB ramp was then deployed so that the surfer could safely board the boat. After the surfer was safely aboard, the pilot boat informed the local authorities and the company, and went to port where the local authorities arrived to receive the surfer.

The crew quickly identified the distressed seafarer and acted promptly, demonstrating excellent vigilance and responsiveness.

- **Maintain Vigilant Watch:** Ensure crew members are always alert and attentive to their surroundings to quickly spot any signs of distress or emergency situations at sea;

- **Stay Updated on Weather Conditions:** Continuously monitor weather reports and sea conditions to avoid dangerous situations, and make informed decisions about navigation and rescue operations;
