List of DP Events

1 Thorough preparation is key

2 There – but not really there

3 Equipment Class 3, even if you operate as ‘Class 2

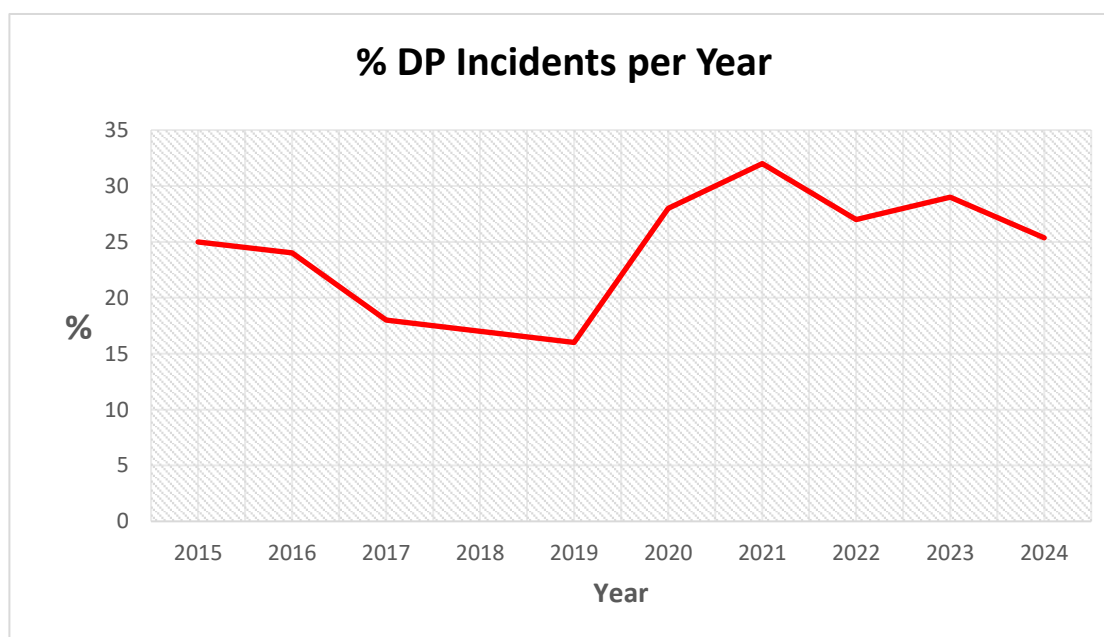
Figure 6 – Percentage of DP Event Reports received resulting in DP Incidents (loss of position/heading)

The percentage of DP incidents (loss of position/heading) reported per year has increased since 2019, a year before the pandemic, which is a concerning trend. The 2022 figures showed that the percentage of incidents had decreased, which was encouraging; however, 2023 showed an upturn. As we enter the final quarter of 2024, this year's figures are still down on last year's.
