IMCA Safety Flash 29/19

Important Safety Notice to Users of Certain Crosby Shackle Products

IMPORTANT SAFETY NOTICE

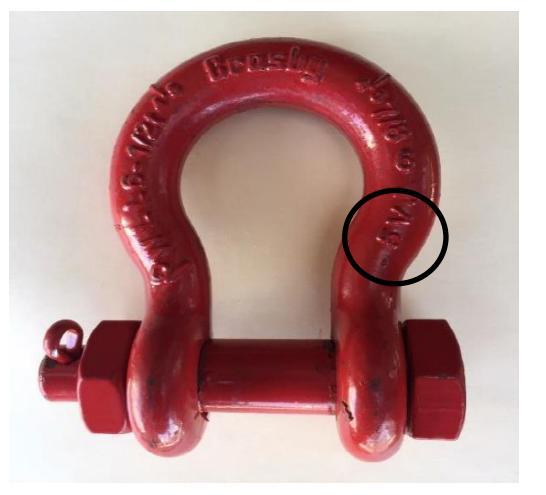
With Production Identification Codes (PIC) 5VJ as located on the shackle bow

By use of the Production Identification Code (PIC) symbols appearing on the product, we have determined the 7/8" 6.5t shackles with PIC 5VJ shown on the bow may have this condition. **See image showing the position of the PIC on the bow.** No other sizes or PICs are part of this Important Safety Notice.

We are requesting you identify all such 7/8" 6.5t shackles with PIC 5VJ, remove from service, and arrange for return and replacement. To return these products, please contact your Crosby Distributor. For more information concerning this Important Safety Notice, contact Technical Support at 1-800-772-1500.
