1 Near-Miss: Missing Grating on Platform in Fuel Tank

2 Recall of Pains Wessex White Collision Warning Hand Flares

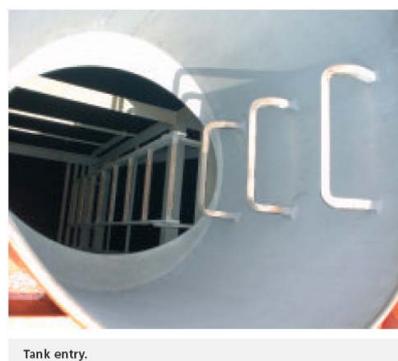
IMCA has received a report of a near-miss involving workers entering a cargo tank. Workers descending a ladder into the tank found that there was no grating platform at the foot of the ladder, leaving an unprotected drop to the bottom of the tank.

Tank entry.

- ◆ When a hinged grating platform is installed:
 - the risk that the platform is left in the open position should be taken into account in the procedures for tank safe entry and discussed at toolbox meetings prior to entering the tank

- cargo tank entry hatches should be fitted with warning signs
- ◆ The recommended checklist for safe entry of confined spaces should be modified to include:

- a check that the platform is in the correct position before descent
 - a check that the platform locking pin has been refitted after the platform has been replaced

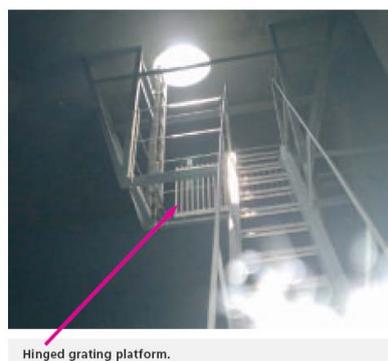
The grating platform was of a commonly used removable type with hinges, often used when the inspection access hatch is combined with the access for hoisting injured persons and/or for maintenance purposes or tank entry sampling. It had been left in a lifted or open position earlier to permit equipment or tools to be hoisted from the tank. No information concerning this had been passed to the workers descending into the tank.

- ◆ The hinged design, though convenient, may compromise safety, as it introduces a significant potential hazard for a tank entry team. A fatal accident has previously been reported where a similar platform was fitted

Hinged grating platform.

- ◆ The safe operation procedure for opening and closing of the platform should be included in the permanent means of access manual (PMA) for newly built vessels.

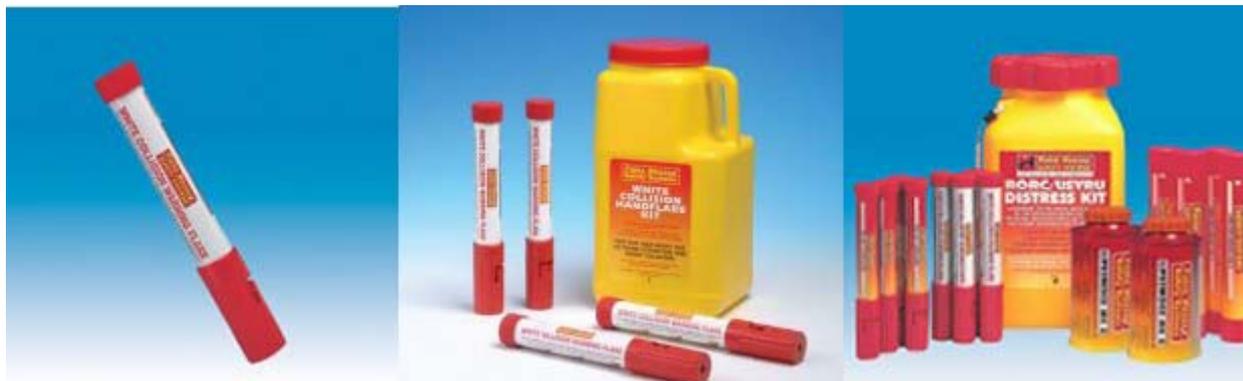
Pains Wessex has announced a recall of its white collision warning (MK7) hand flares, item number 52651. The recall follows a recent incident in which an individual was seriously injured while using this flare. Pains Wessex has identified that there may be a risk that some of these white flares will not fire as intended. All white flares are therefore being recalled as a safety precaution.

The Pains Wessex white collision warning (MK 7) hand flare, item number 52651 is sold on its own and is also contained as a part of the company's collision warn-off kit and the ORC RORC distress kit as illustrated below.

Customers with in-date Pains Wessex white collision warning (MK7) hand flares are advised not to use the flare and are asked to return it immediately to the place of purchase where the purchase price will be refunded. If unable to return the flare to the place of purchase, customers may take the flare to their nearest chandler.
